# Honda Accord LX Broadside Collision With a Narrow Fixed-Object: FOIL Test Number 97S006

PUBLICATION NO. FHWA-RD-98-011

JANUARY 1998

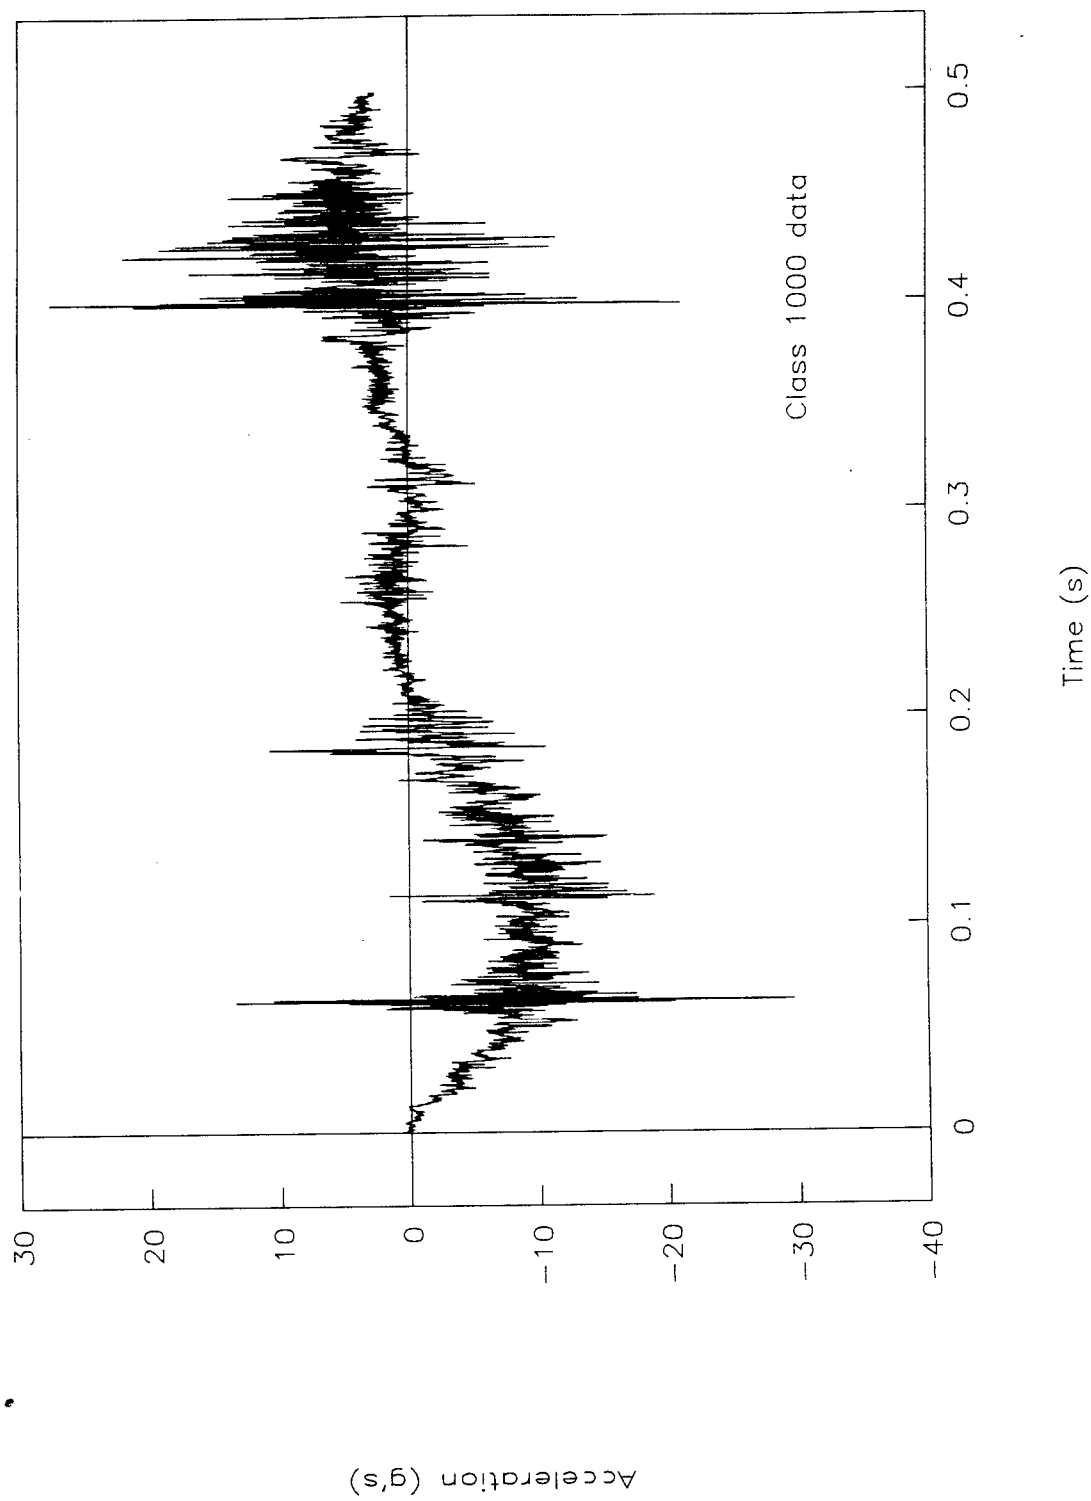
Figure 16. Acceleration vs. time, Y-axis trunk, test 97S006.

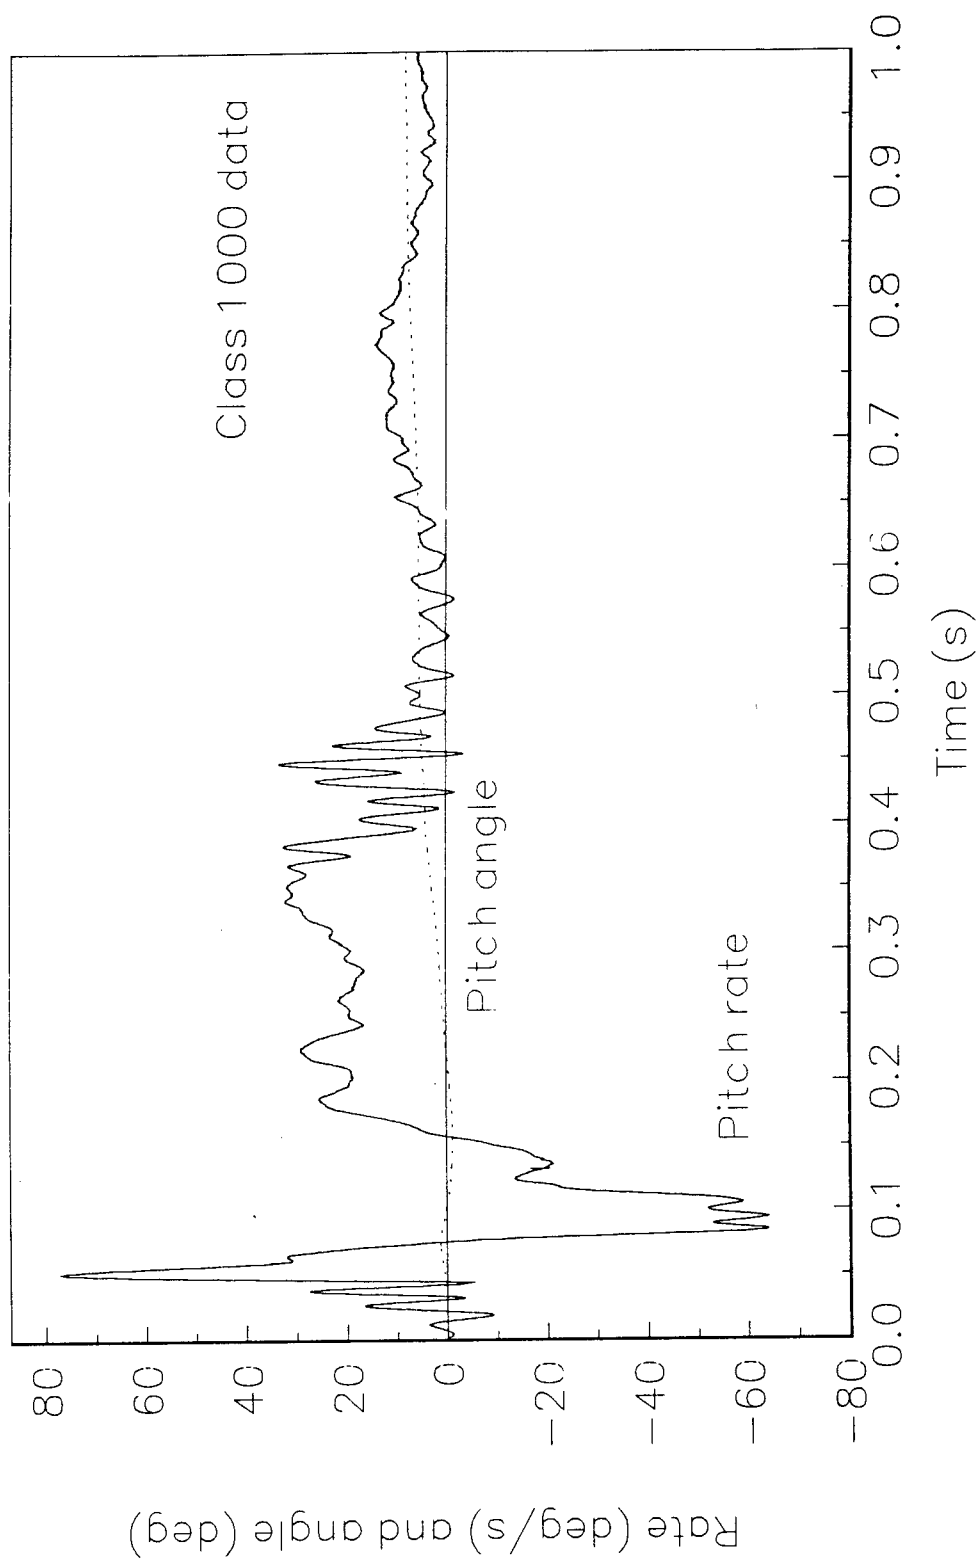
Figure 17. Pitch rate and angle vs. time, test 97S006.

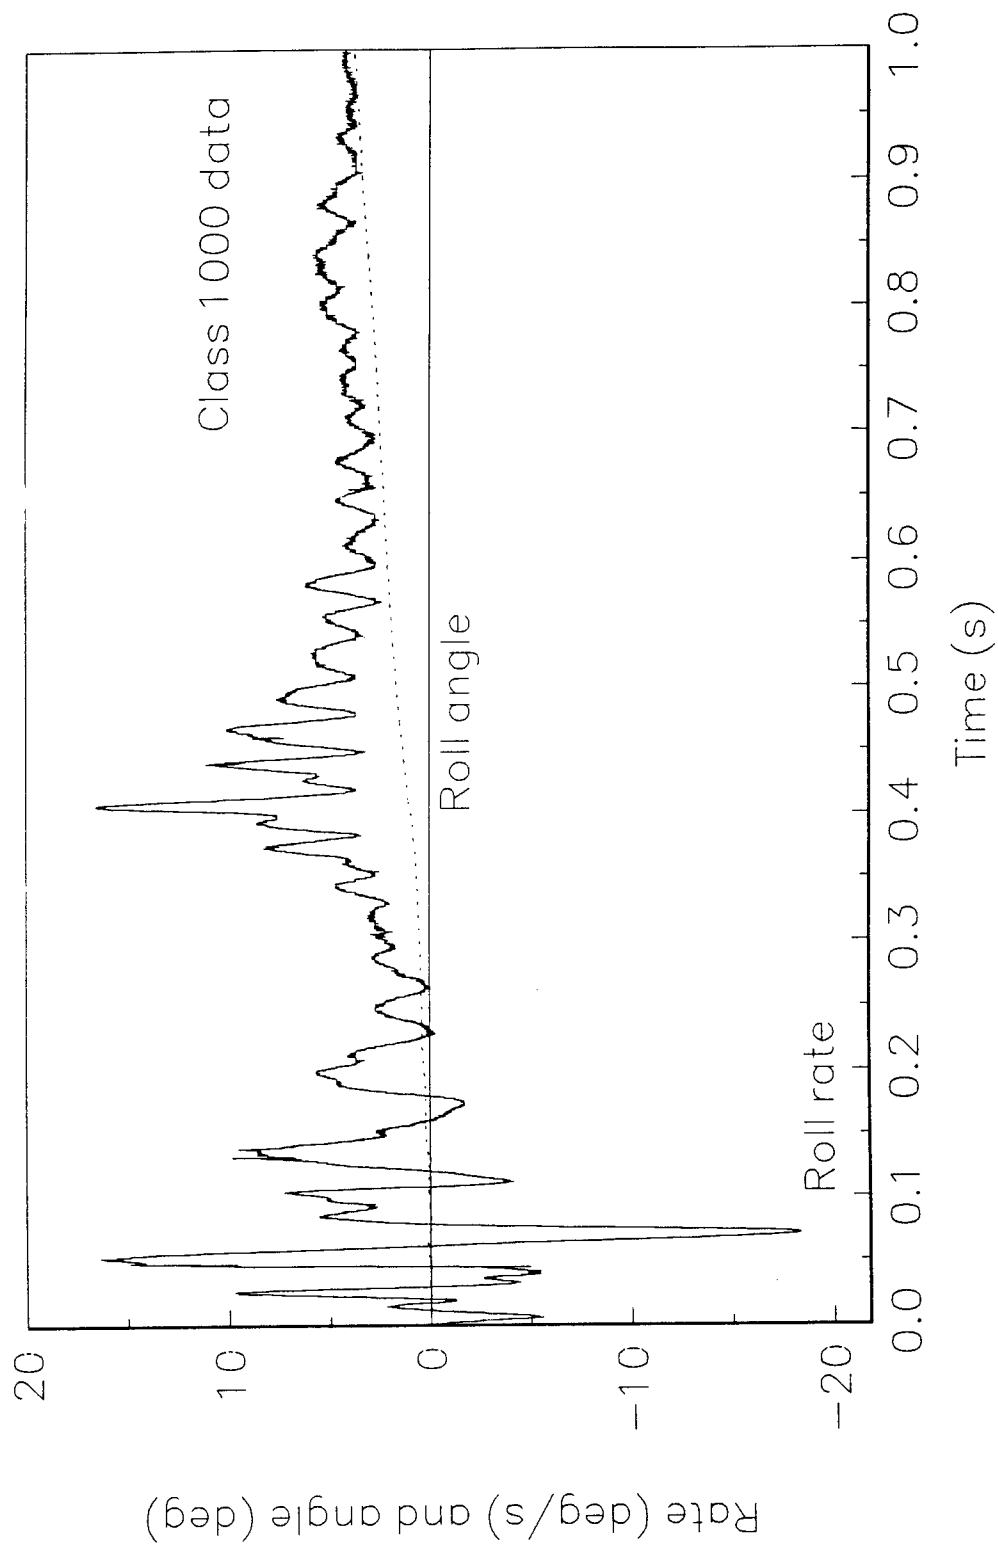
Figure 18. Roll rate and angle vs. time, test 97S006.

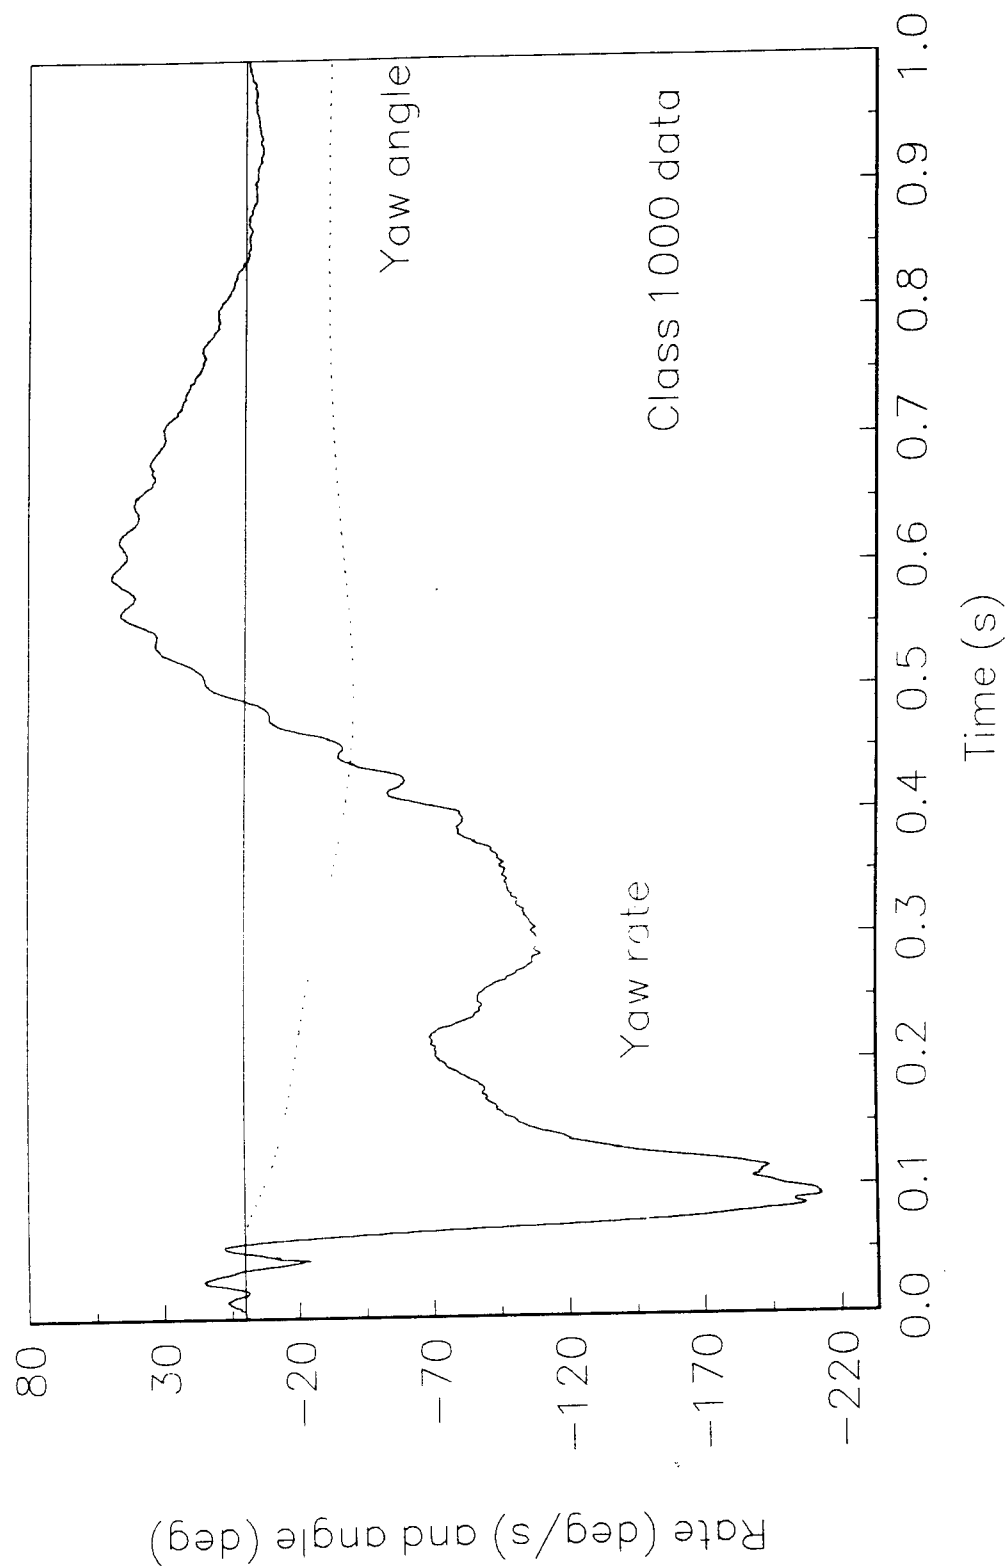
Figure 19. Yaw rate and angle vs. time, test 97S006.

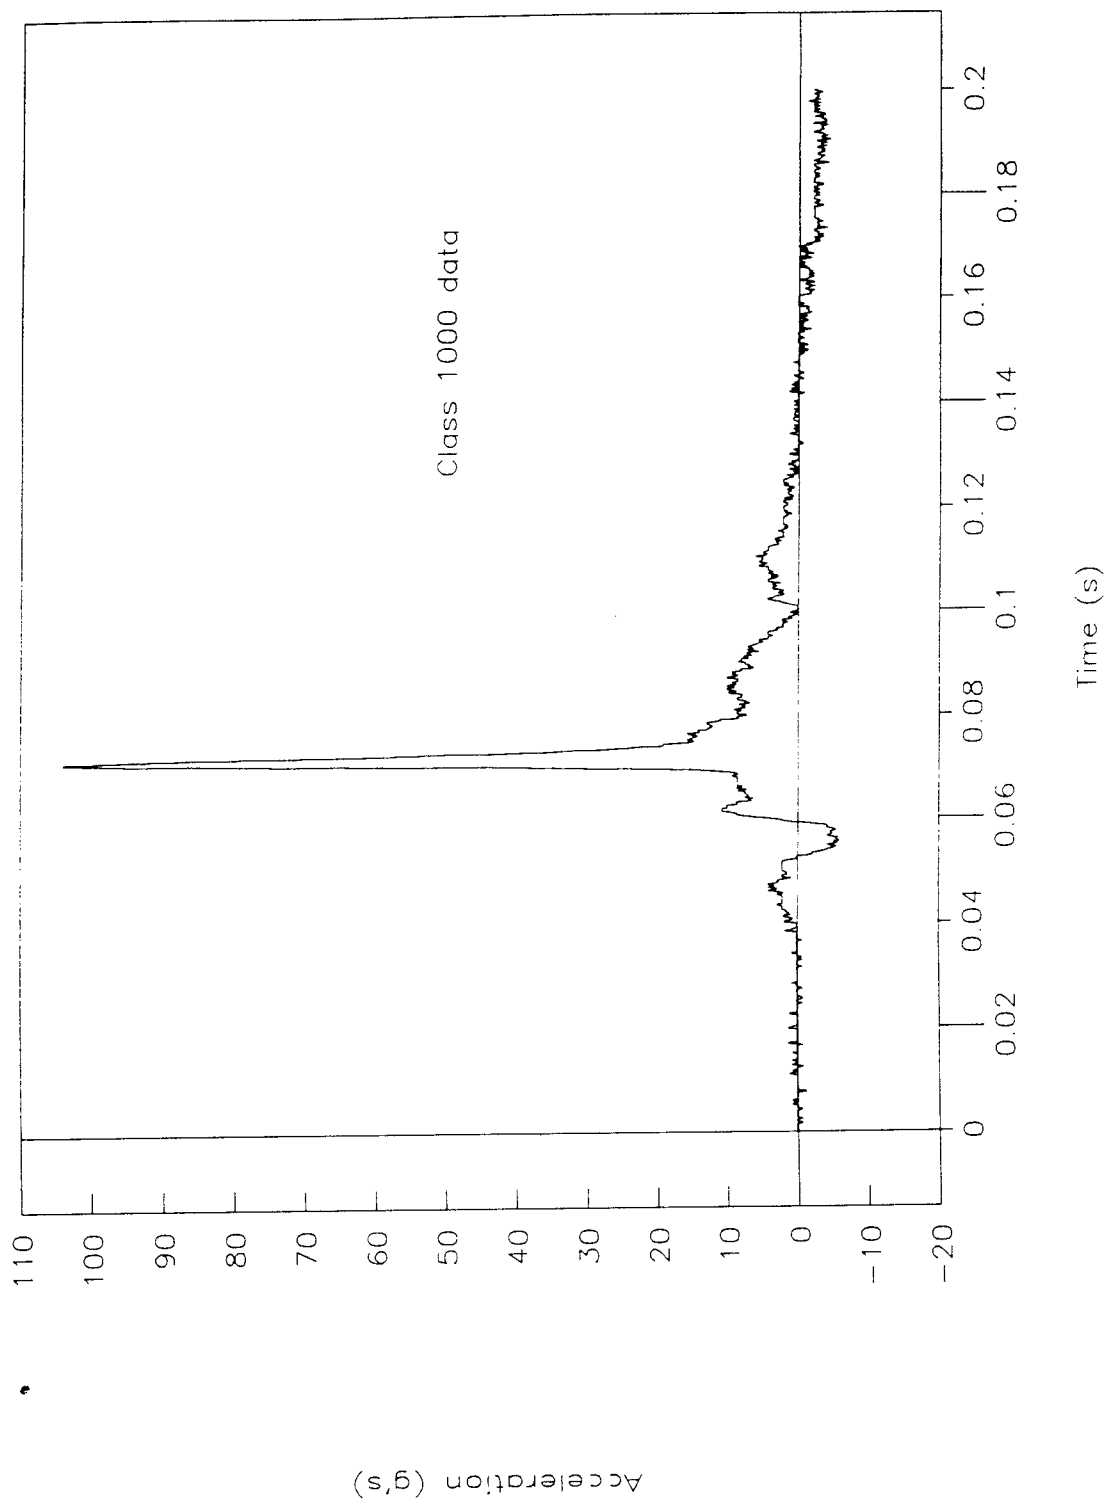
Figure 20. Acceleration vs. time, X-axis head, test 97S006.

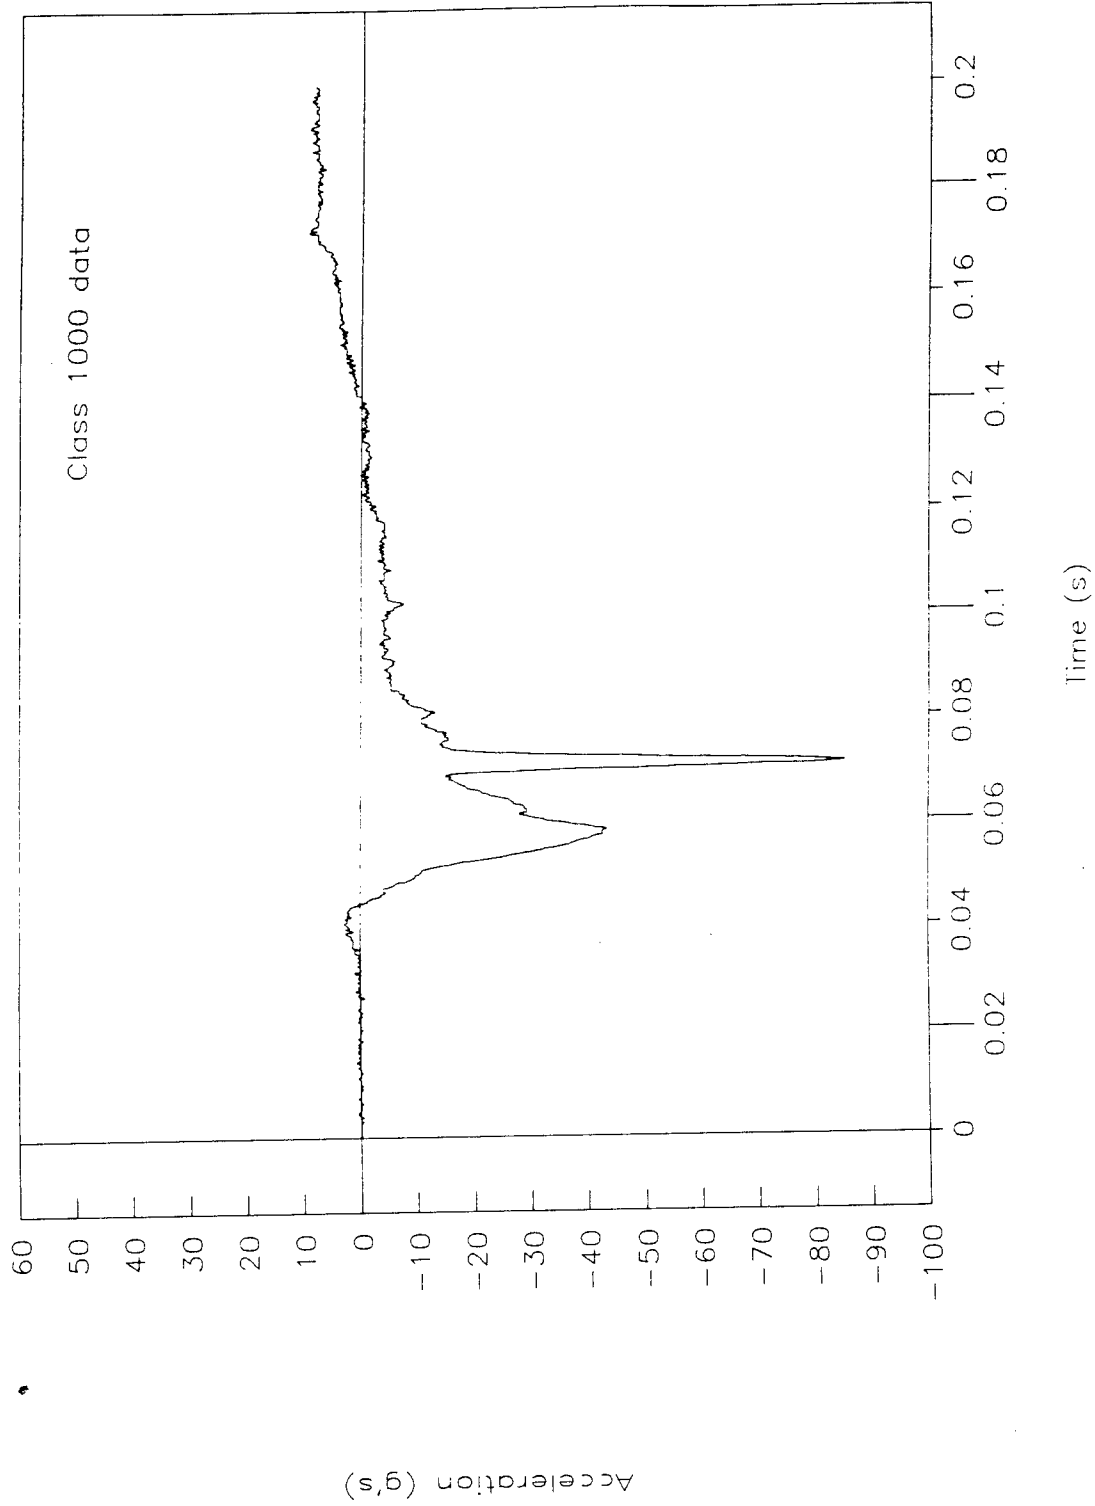
Figure 21. Acceleration vs. time, Y-axis head, test 97S006.

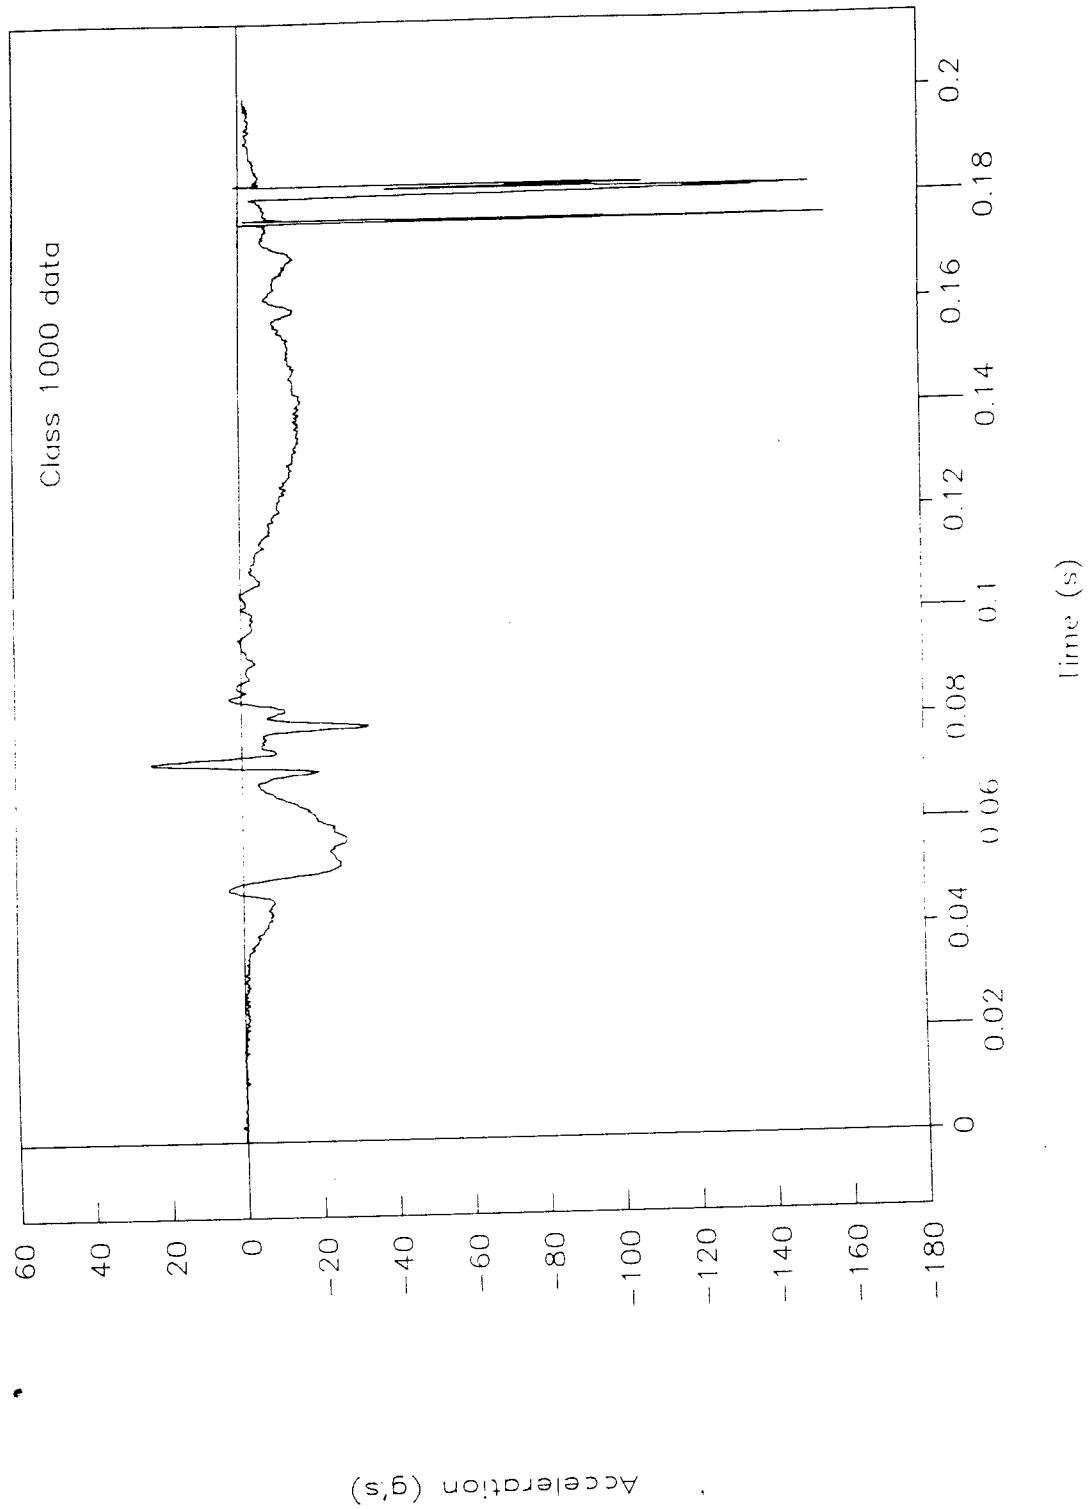
Figure 22. Acceleration vs. time, Z-axis head, test 97S006.

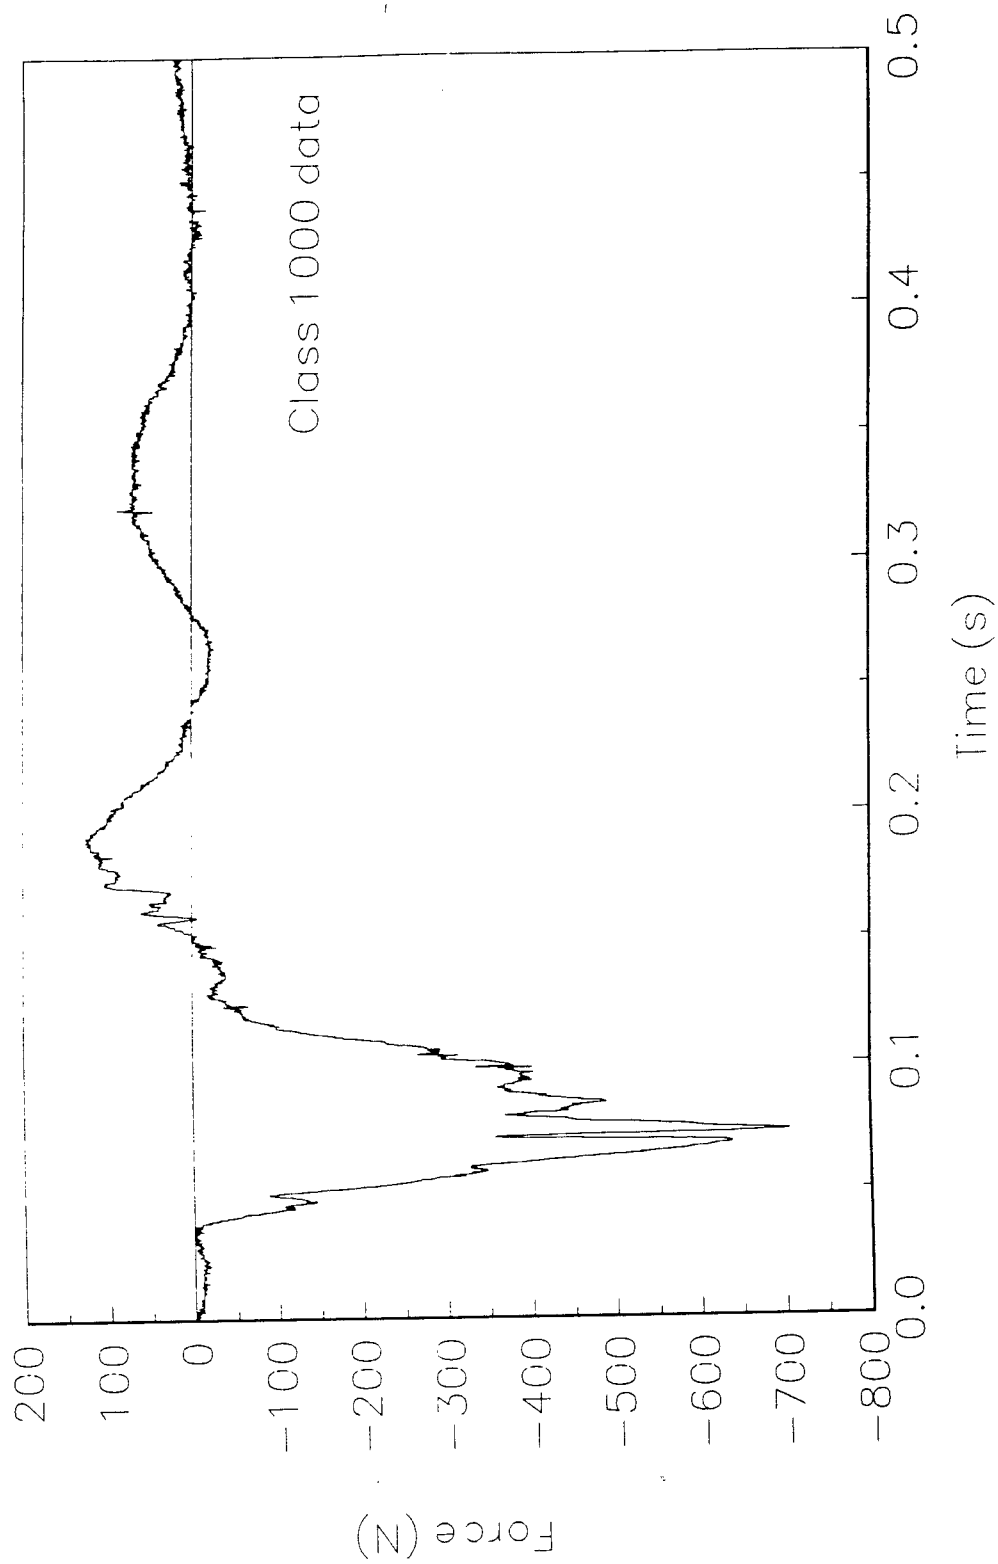
Figure 23. Force vs. time, X-axis neck, test 97S006.

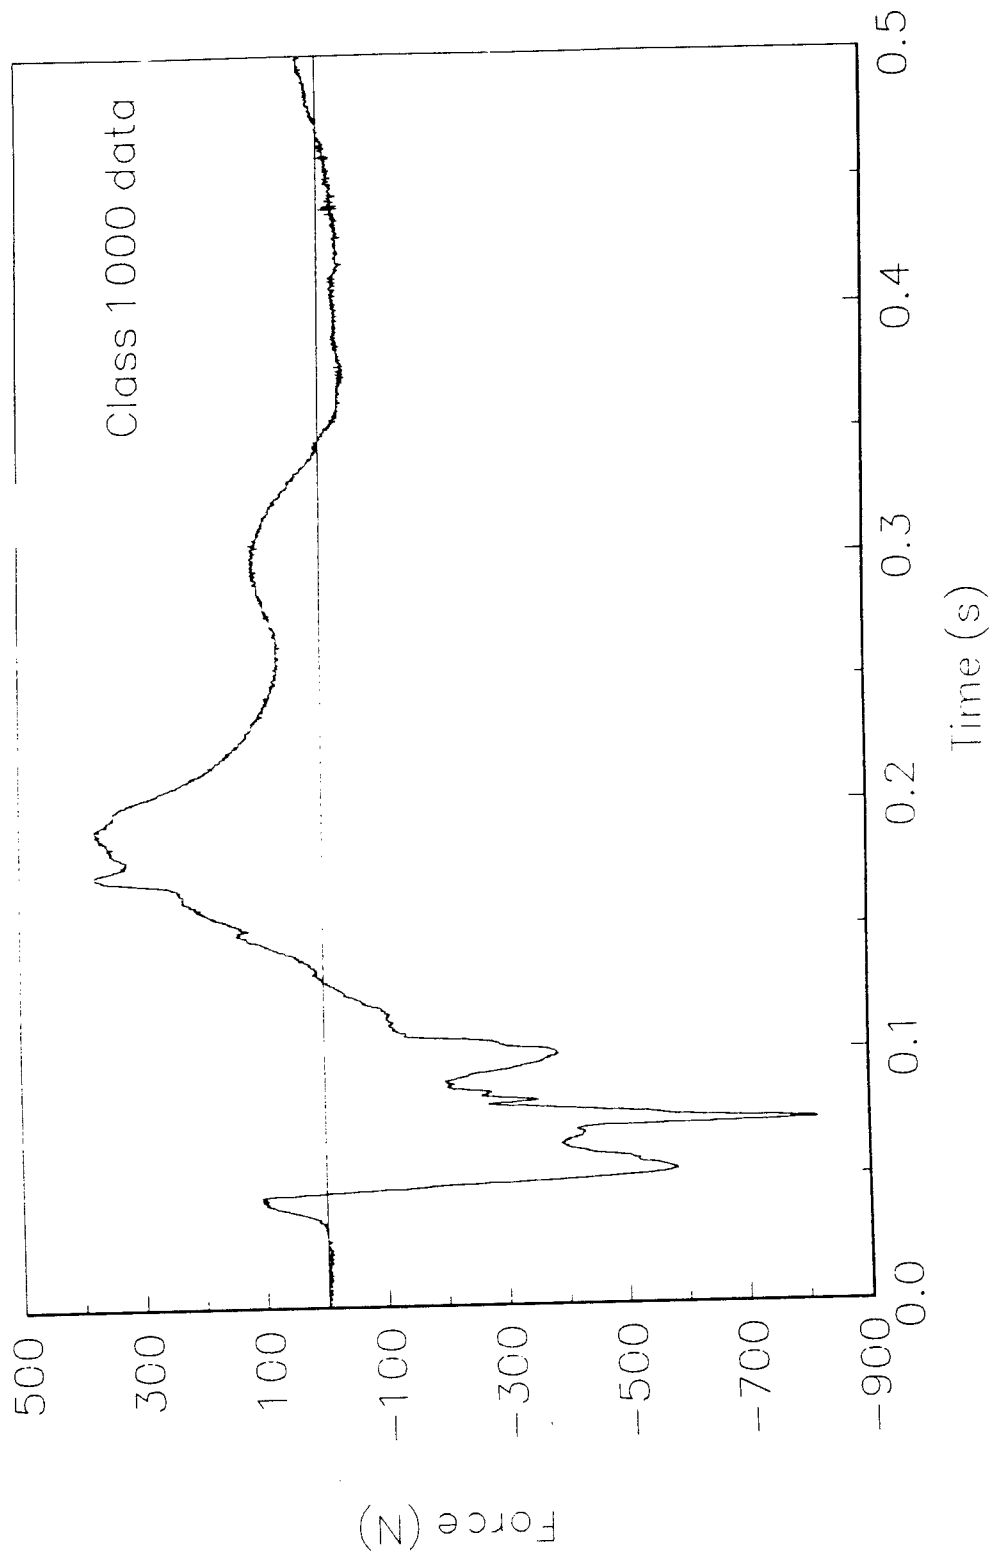
Figure 24. Force vs. time, Y-axis neck, test 97S006.

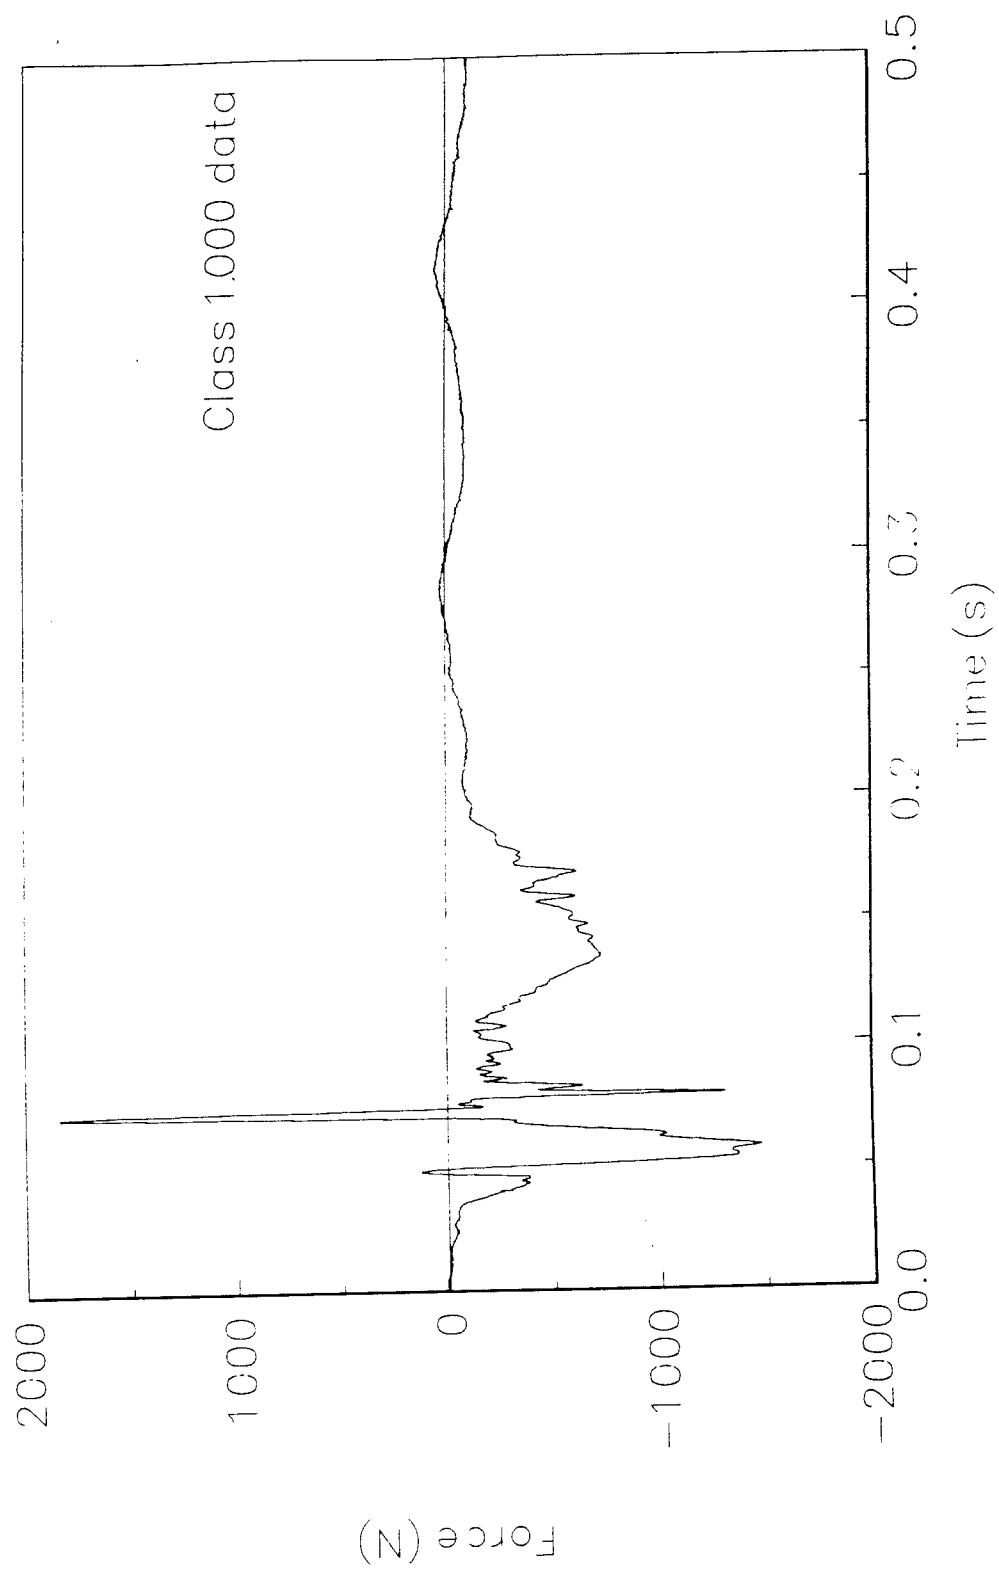
Figure 25. Force vs. time, Z-axis neck, test 97S006.

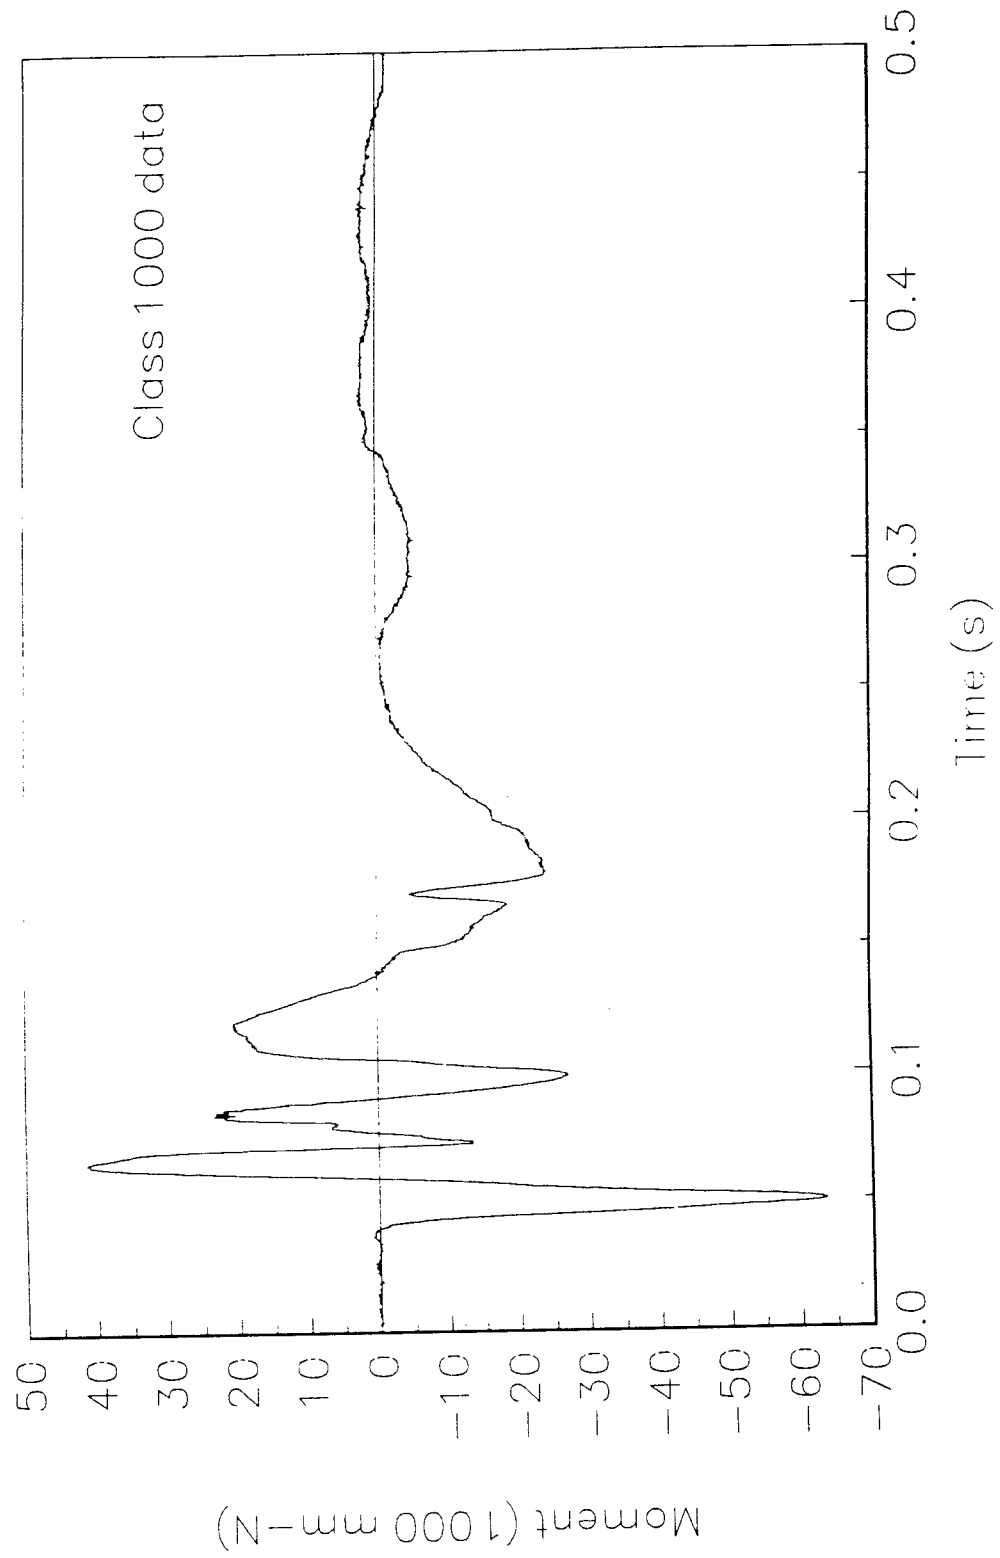
Figure 26. Moment vs. time, X-axis neck, test 97S006.

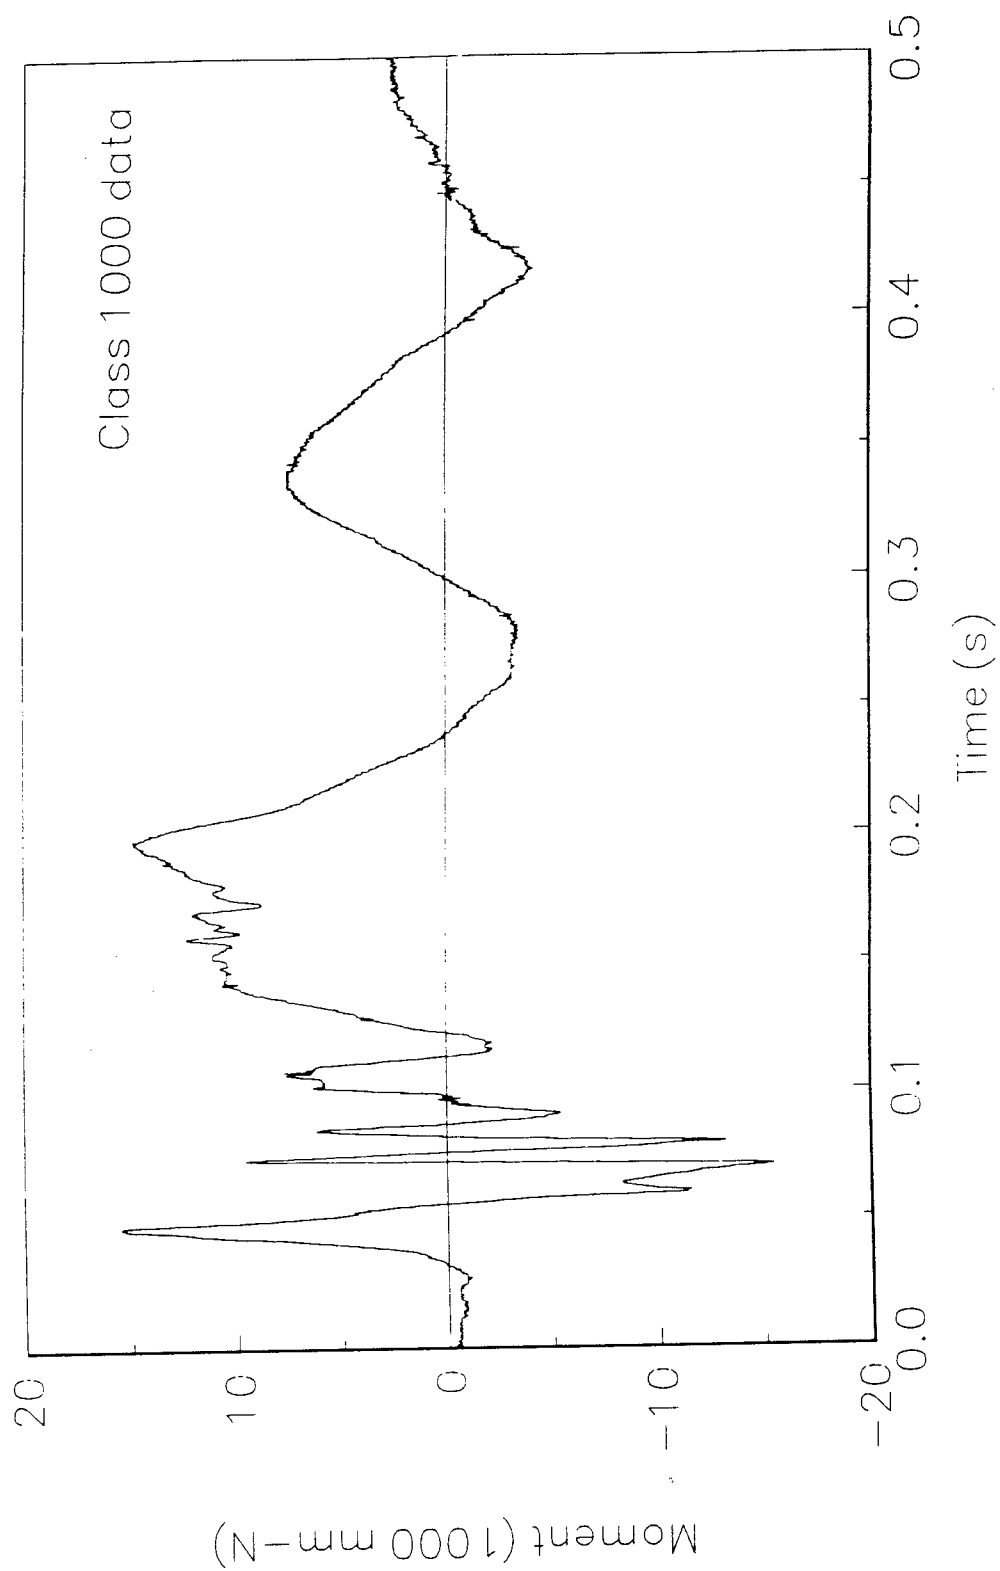
Figure 27. Moment vs. time, Y-axis neck, test 97S006.

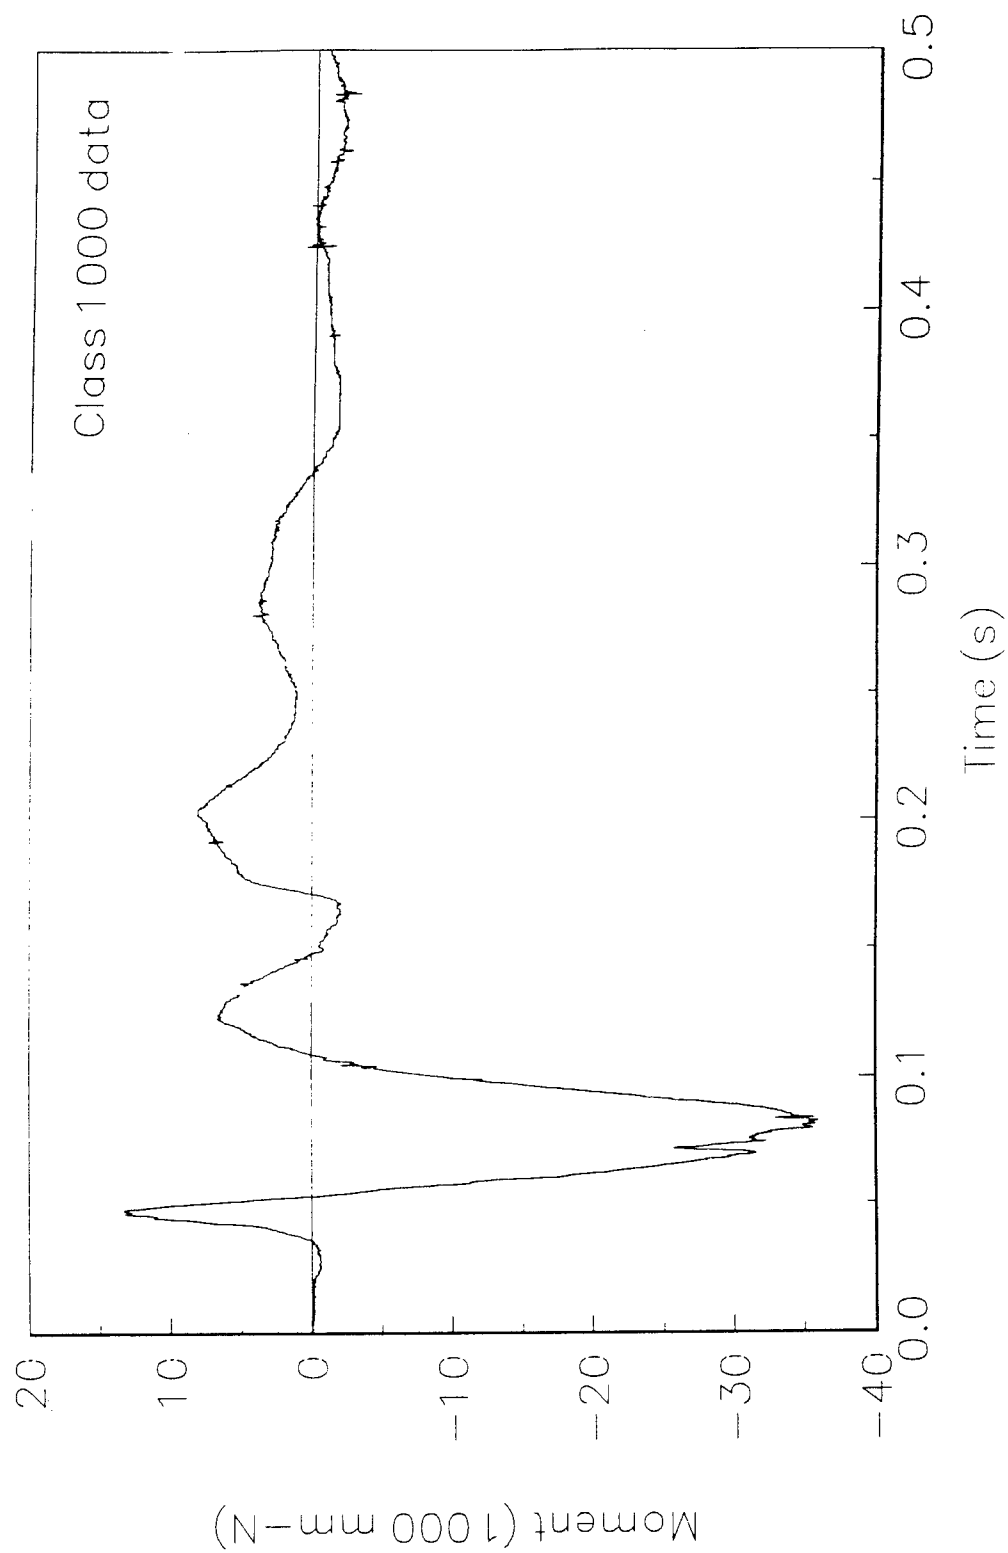
Figure 28. Moment vs. time, Z-axis neck, test 97S006.

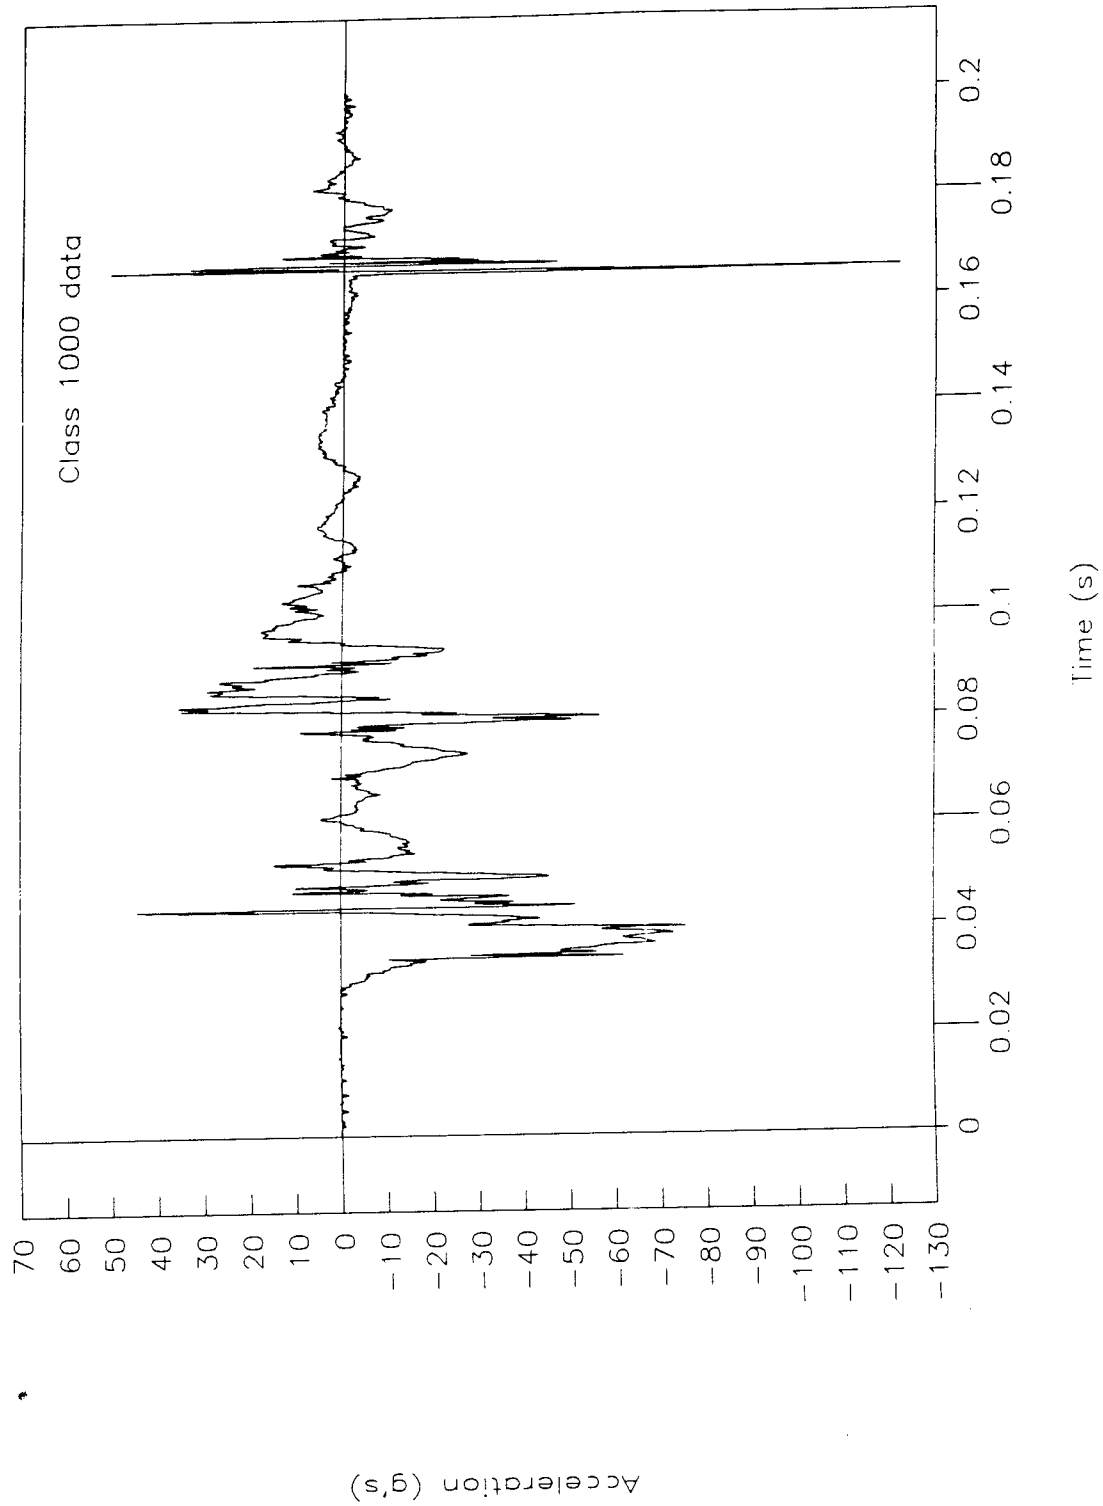
Figure 29. Acceleration vs. time, primary upper rib, test 97S006.
